Preventable Anesthesia Mishaps: An Overview

We report a case of malposition of the vaporizer on the selectatec manifold of the anesthesia workstation leading to interruption in the fresh gas flow at anesthesia machine outlet. We emphasize the importance of checking the anaesthetic vaporizer after mounting it on the backbar of the anesthesia workstation.

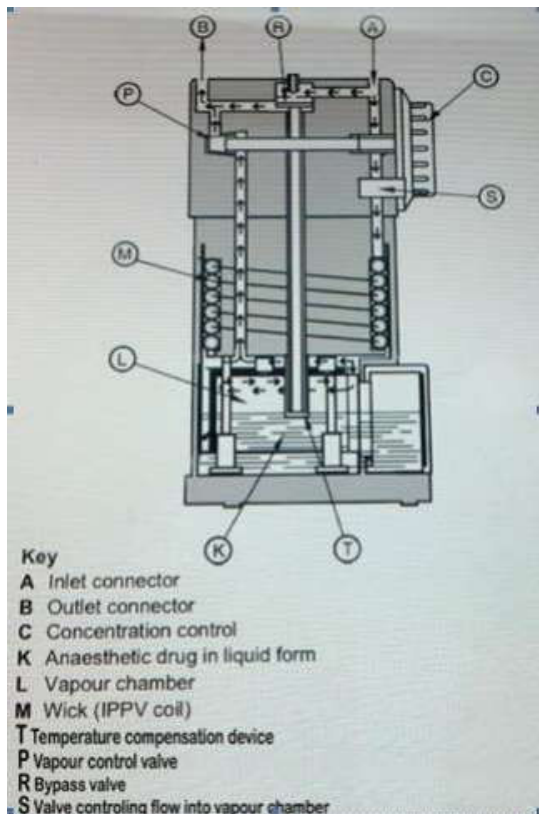
Fig. 1:

with tidal volume of 500 ml, frequency of 12 /min, I:E ratio of 1:2. Anesthesia plan for maintenance included air-oxygen mixture, isoflurane, intermittent doses of rocuronium and fentanyl. Around 3-5 minutes after connecting to the ventilator, there was a low minute volume alarm and the bellows started collapsing. Immediately we looked for any cuff leak, circuit disconnections, loosening of CO₂ canister and malfunctioning of the valves but couldnot find any fault with them. So, an attempt to ventilate was made by changing to manual ventilation with increased FGF and later tried by connecting the Bain's system to auxiliary common gas outlet but there was inadequate filling of the reservoir bag. The bag could only be filled by activating the oxygen flush which was also short lived as enough pressure could not be generated. This guided us to have a strong suspicion about anesthesia machine malfunction to be the cause for ventilation failure and the patient was immediately disconnected from the workstation and was ventilated with a manual resuscitator until another workstation was ready for use. Simultaneously, we watched the patients vital parameters with a vigilant eye and found it to be stable throught this period. Meanwhile the previous anesthesia workstation was inspected and we could not find anything functionally wrong except that the isoflurane vaporizer was slightly lifted up and tilted to one side and the locking lever was not in place. The concentration control dial could be turned on and when the test lung was attached, it barely inflated. The vaporizer was removed, remounted properly, checked again for any leak by attaching the test lung and after confirming for its proper functioning by complete inflation of the test lung it was reconnected to the patient and the

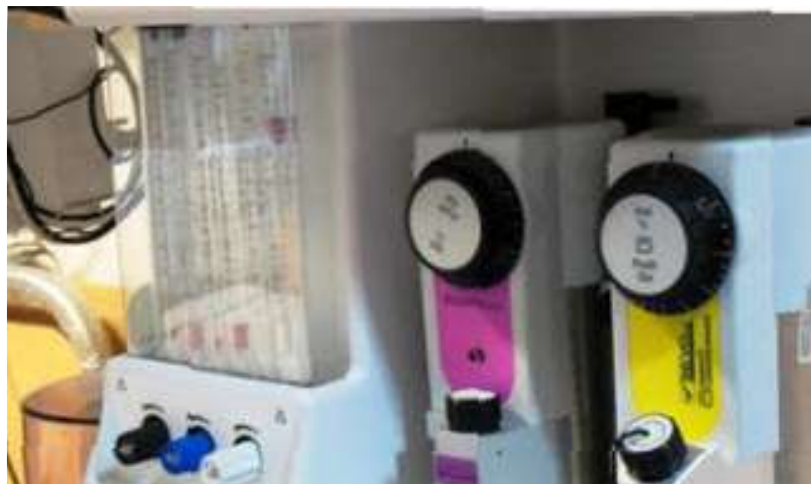
Fig. 2:

dial could be opened even when there was a faulty mounting of the vaporizer on the manifold leading to interruption in the FGF at the outlet. However, because of quick detection and rectification of the problem there was no signs of hypoxemia or hypercarbia noticed in our case. This case report highlights about the fault which is not detectable by performing the routine anesthesia machine check as recommended by the manufacturers and also the importance of anaesthetic agent monitors in detection of such faults. It also provides an insight into the lapses and lacunae in the level of training, alerts us about equipment malfunction, human errors and emphasizes that constant vigilance of the anesthetist is highly essential for the safe conduct of anesthesia.
