## A Series Case Reports of Four Accidental Sewer Gas Poisoning

### Case Report One A

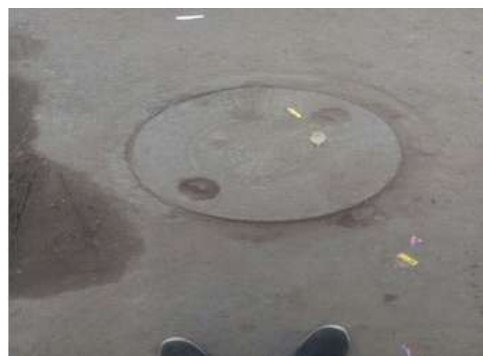
Fig. 1: Sewage hole
